## LARGE MINING OPERATIONS 2007 PROGRESS REPORT January 1, 2007 to December 31, 2007

1.	Mine Permit Number: M/023/003
2.	Mine Name:Topaz Mining Property
3.	Name of Operator/Permittee: Brush Resources Inc.
	Note: If Operator's address, company representative or phone number have changed, please provide a replacement page to the Notice of Intention.

### SUPPLEMENT TO FORM MR-AR-LMO

**SUBJECT:** TOPAZ MINE - FLURO PHASE 1 RECLAMATION

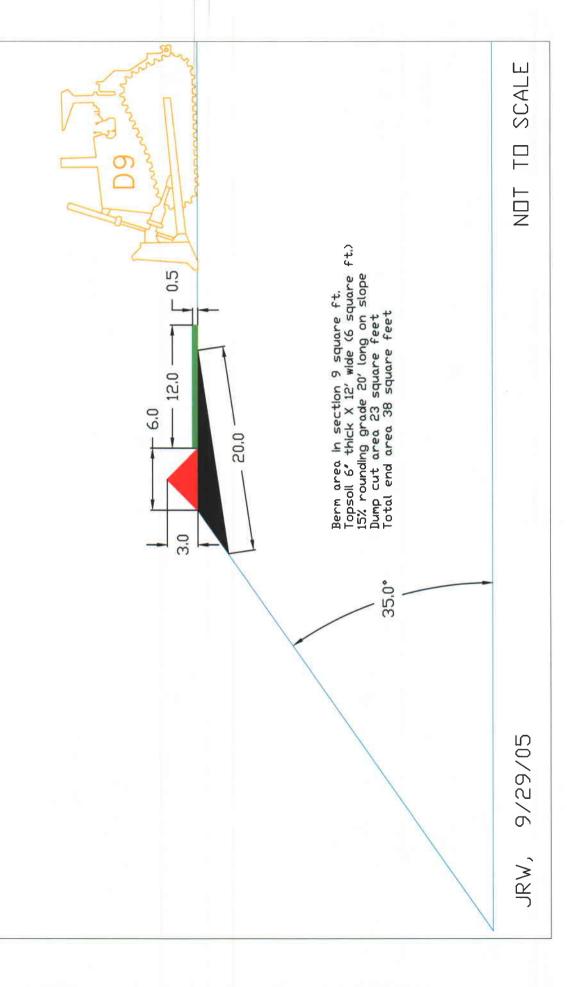
# Dump Top Rounding Schematic Brush Resources Inc.

- The rounding is a standard reclamation treatment intended to blend the dump crest to the surrounding terrain and reduce erosion (see MRP section 7.4.2 and attached schematic).
- b. The Plan estimated 989 linear feet of rounding for the three Fluro LMUs (see Appendix 8, section 9.4 of the MRP). The actual length of rounded perimeter was approximately 1,600 feet. There was an omission of a measured portion of the margin during the surety calculations for this area. Please note that the entire perimeter length was rounded.

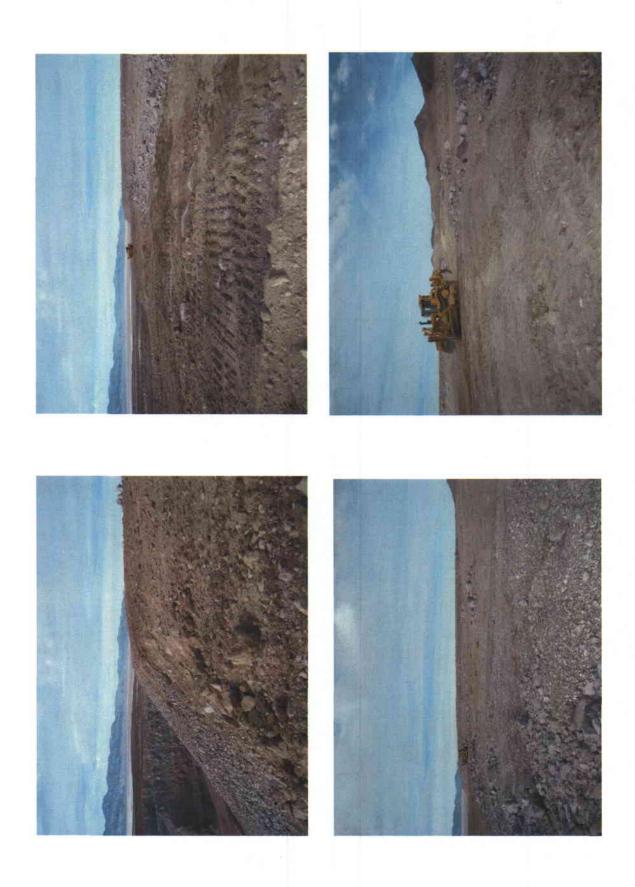
Fluro Phase 1 backfill top surface - perimeter rounding & topsoil distribution

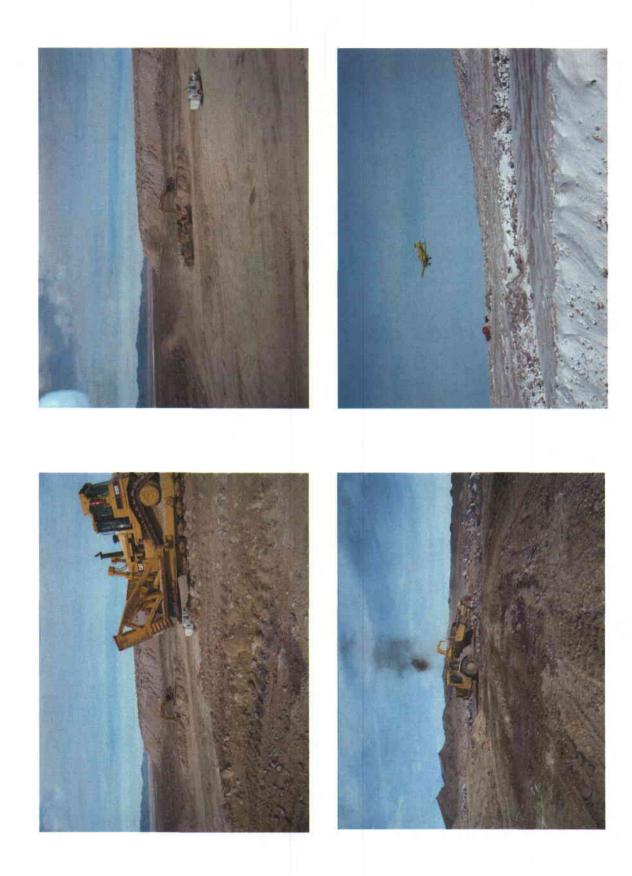
Fluro Phase 1 backfill top surface - topsoil handling & spreading; aerial broadcast seed

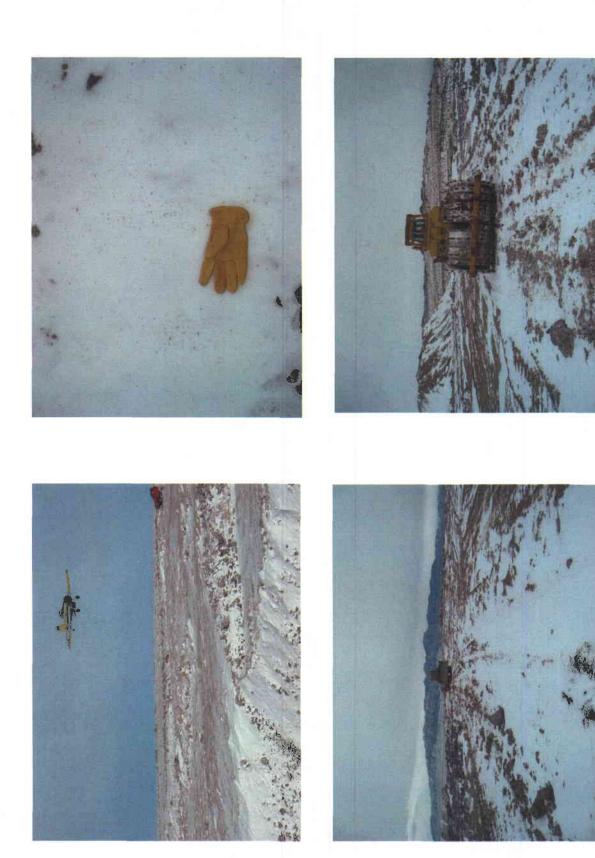
Fluro Phase 1 backfill top surface - aerial broadcast seed; sheepsfoot treatment
